September 23, 2022

Re: Executive Summary Report
Limited and Directed Asbestos Sampling and Lead screening
Former Fair Oaks/Community Center
836 Old Colchester Rd. (Bathrooms near Gym only)

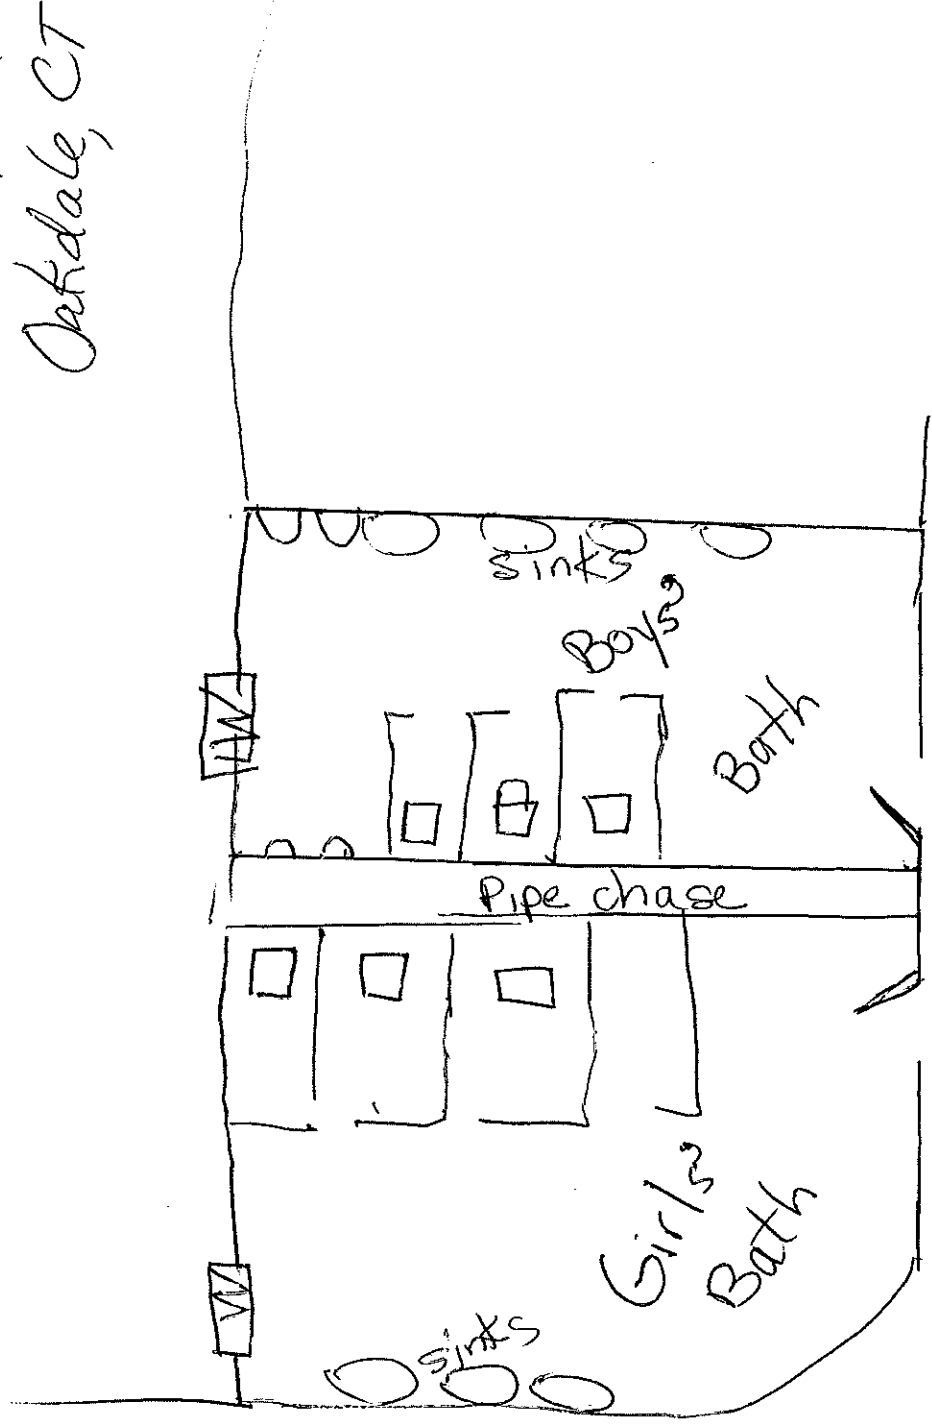
<u>Sample #s</u>	<u>Materials/ Location</u>	<u>Estimated Affected Area</u>
16-18	All pipe fitting insulation Pipe chase between bathrooms & assumed in sink walls	80 sq. ft. Girls and Boys bathrooms

The surfaces found to be lead include the wall tile in the Boys bathroom and the Black border tile in the Girls Bathroom. Both these surfaces were in intact condition when tested.

Gym →

Main Entrance

Hallway

Federal and State regulations require abatement by a certified asbestos abatement contractor of these materials prior to disturbance by renovation or demolition. Or arrange to have demolition done by asbestos abatement contractor under containment.
